09/2009: Moron Air Base, Spain

TrackJet® removes runway rubber for US Air force Base Moron in Spain

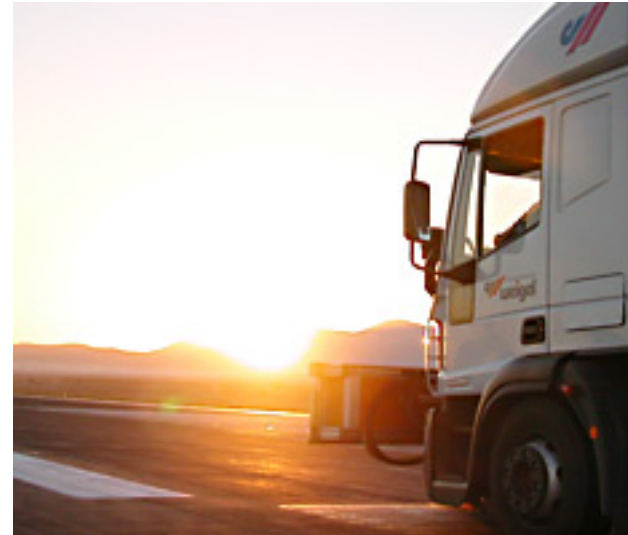
Rubber deposits were already quite significant on both touch-down zones, as the previous rubber removal intervention took place more than 3 years before, and both runway ends are frequently used for landings.

The elliptical typical shapes of rubber marks were covering an asphalt area and also the concrete ends, with an extension of around 300m, almost up to the threshold lines. The rubber removal operations were performed every day, during the periods with less aircraft movements, to minimize interruptions.

One of the most recent TrackJet models, TJ-24 complete with high capacity vacuum suction system, successfully achieved the demanding degree of removal USAFE defined (up to 90 %) without damaging the surface, and granting an average speed of 700 sqm/h, and even more on concrete areas.
