2009-09: Moron Air Base, Spain

## TrackJet® removes runway rubber for US Air force Base Moron in Spain

September 2009: German high pressure water jet systems manufacturer Weigel has recently completed over 40,000 m<sup>2</sup> of rubber removal services, at the Moron Air Base runway.

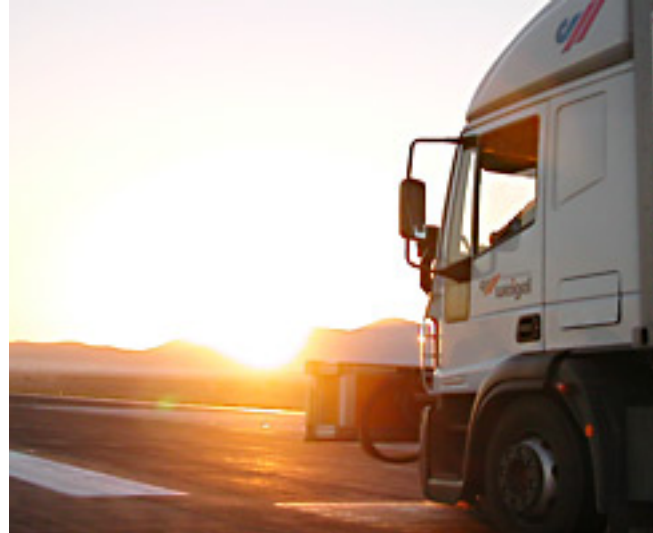
Rubber deposits were already quite significant on both touch-down zones, as the previous rubber removal intervention took place more than 3 years before, and both runway ends are frequently used for landings.

The elliptical typical shapes of rubber marks were covering an asphalt area and also the concrete ends, with an extension of around 300m, almost up to the threshold lines. The rubber removal operations were performed every day, during the periods with less aircraft movements, to minimize interruptions.

One of the most recent TrackJet models, TJ-24 complete with high capacity vacuum suction system, successfully achieved the demanding degree of removal USAFE defined (up to 90 %) without damaging the surface, and granting an average speed of 700 sqm/h, and even more on concrete areas.

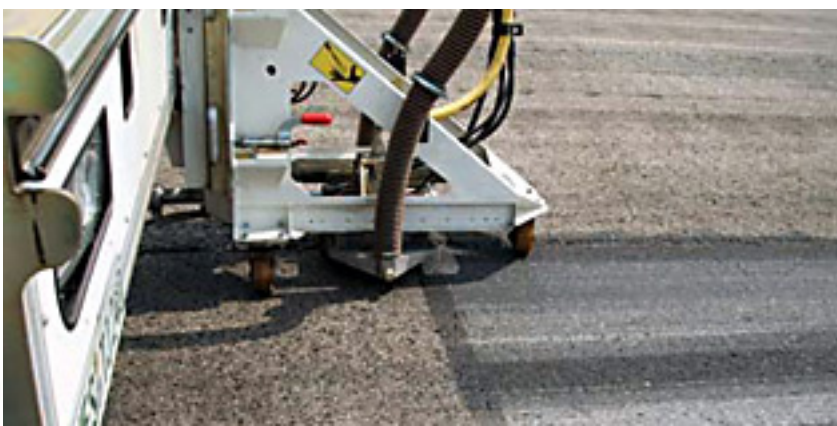
Using an exclusive computerized control system, the TrackJet removed rubber on two different pavement types, with homogeneous results, without damaging the surface, the paint marks, the sealings or the arresting system.

The positive results were especially impressive on concrete, not due to a higher removal rate, or to a lower rubber accumulation layer, but most of all, because the color contrast between the black rubber and the grey concrete was even more evident there.
